“Set Fier to the Town of Charlestown wich Consumed almost Every House in that Town”: An Analysis of Window Leads from the Three Cranes Tavern Site

Timothy B. Riordan

A lack of published data on window leads from sites in New England prompted a project analyzing the sample from the Three Cranes Tavern site in Charlestown, Massachusetts. This structure was built ca. 1629 in anticipation of John Winthrop's arrival to settle Massachusetts Bay. For most of its existence it was used as an ordinary. Like the rest of Charlestown, it was destroyed on 17 June 1775 during the Battle of Bunker Hill. Excavated as part of the “Big Dig” in 1985, the recovered sample included 148 items identified as window leads. Within this sample were window leads, window ties, and a small sample of scrap lead. The marked leads are described and an analysis of the physical characteristics of the leads is presented. A study of the window ties describes three types and relates them to historically known manufacturing processes.

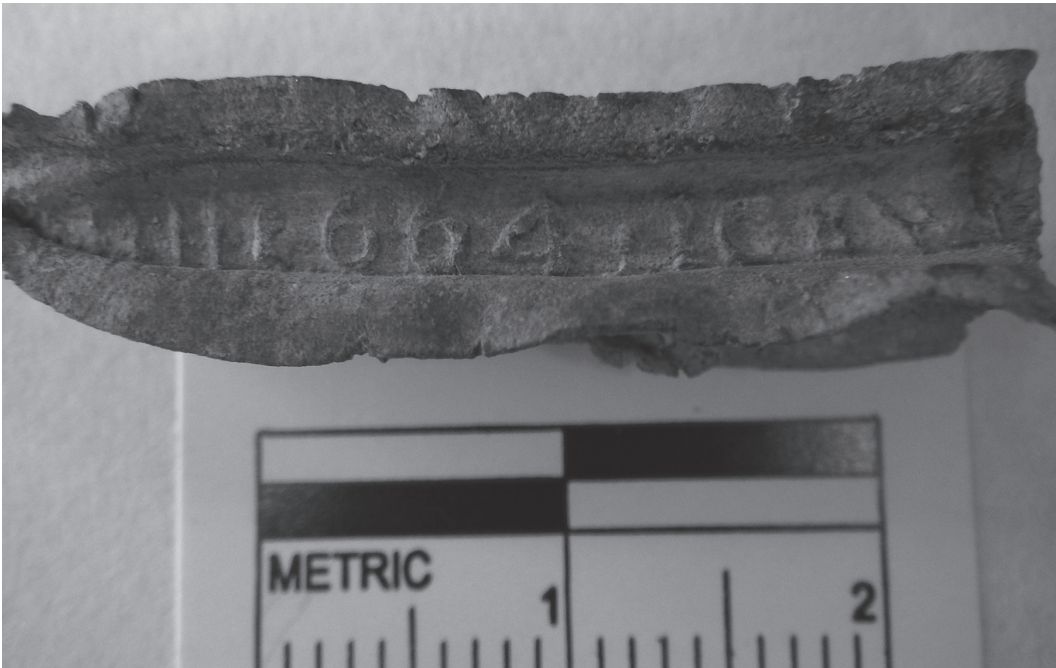
Figure 2. Lead marked: 1664 • ICEW •. (Photo by Timothy B. Riordan, 2018.)

By far the most common mark was dated 1664 and was followed by the initials: ICEW (fig. 2). This mark accounted for 79% of all the observed marks. It was found on 14 lead segments, mostly as a single mark, but with two examples on 1 segment and five on another. This mark has not been reported outside New England but appears to be common in this area. The 1664-dated lead found at the Turner House in Salem, Massachusetts, illustrated by Goodwin (1999: 92), is broken off and missing the initials, but appears to be in the same font as the marks from the Three Cranes Tavern site. Baker (2009: 10) reported two 1664 marks with the initials. In total, there are 22 examples of this mark from New England. Given the small number of leads that have been examined in New England thus far, this is a remarkable concentration. Despite the large number of leads examined in other areas, no 1664 marks nor any similar combination of initials have been reported. This raises several possibilities, none of which can be verified at this point. It is possible that the leads were made by a glazier working in New England. While there is evidence that glaziers were practicing in Massachusetts by 1650 (Cummings 1979: 42), no one has yet found a glazier’s vice¹ listed in a 17th-century inventory. However, as early as 1725 a blacksmith in Boston advertised that he not only repaired glaziers’ vices but made them as well (*New England Weekly Herald* 1732). Certainly, by the early 18th century, New England glaziers were capable of turning their own leads. Another possibility is that the vice was used by a glazier in England whose overseas trade was with merchants who dealt exclusively with New England.

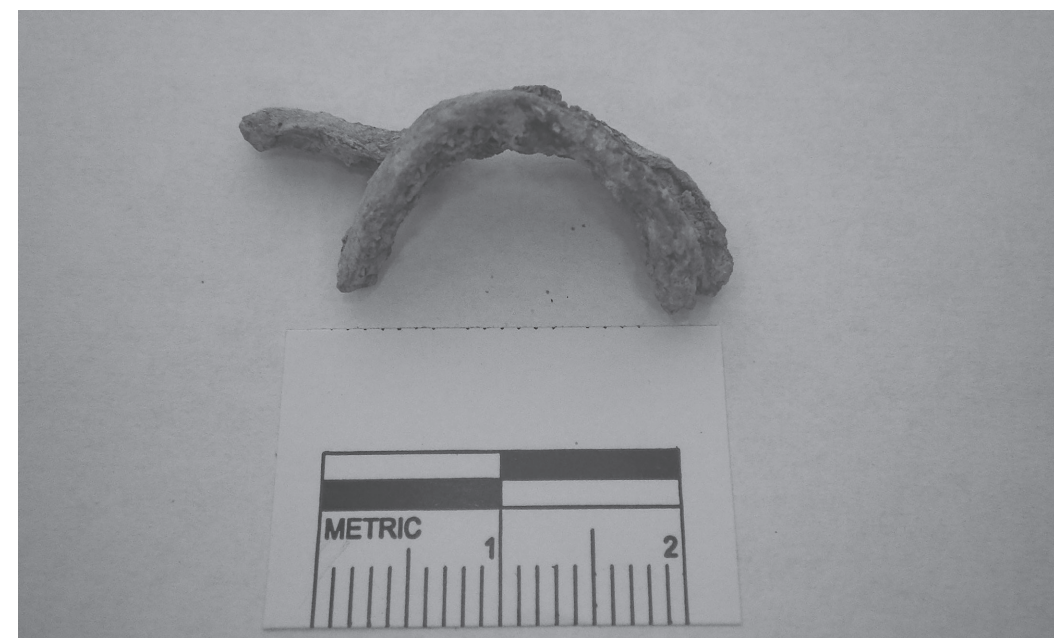
Figure 4. Window tie showing shape of a saddle bar. (Photo by Timothy B. Riordan, 2018.)

Another class of lead artifacts associated with leaded windows are the ties that were used to attach the leaded sash to the saddle-bars (FIG. 4). The saddle-bars, or stay bars, can be of either wood or iron. According to Cummings, a "typical casement ... is fitted with three horizontal stay bars that stiffen and support the glass. Narrow strips of lead are bent around these stay bars and are soldered to the lead 'comes' or dividers that hold the individual diamond-shaped panes of glass" (Cummings 1979: 155).

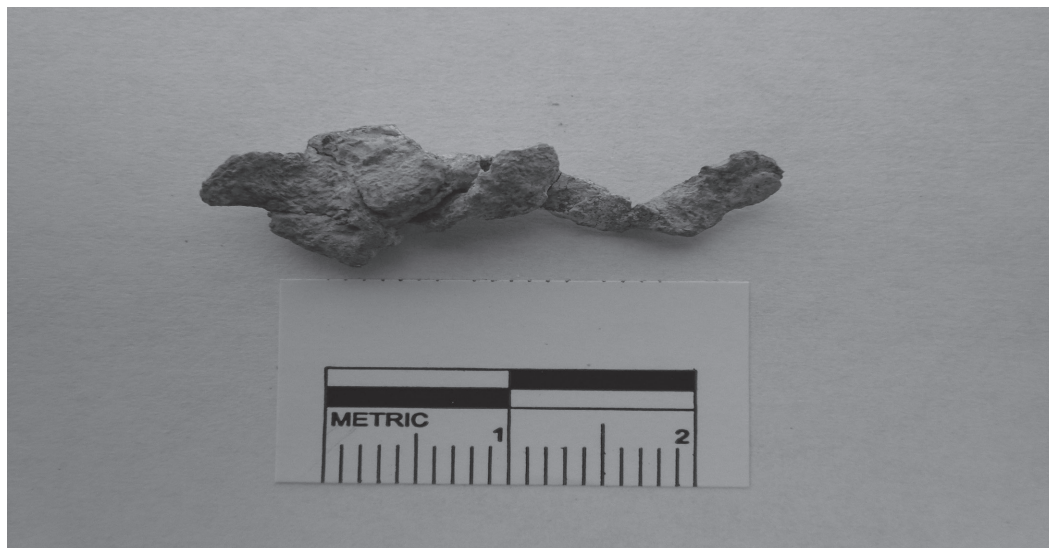
Figure 6. Cast window tie with a twisted end. (Photo by the Timothy B. Riordan, 2018.)

twisted ends from the process of tying them to the saddle-bar, and one had a curved section that had been around the saddle-bar (FIG. 6). The diameter of the curve, reflecting the bar, was 10.5 mm. There was no iron staining on the lead, so the saddle-bar may have been of wood.

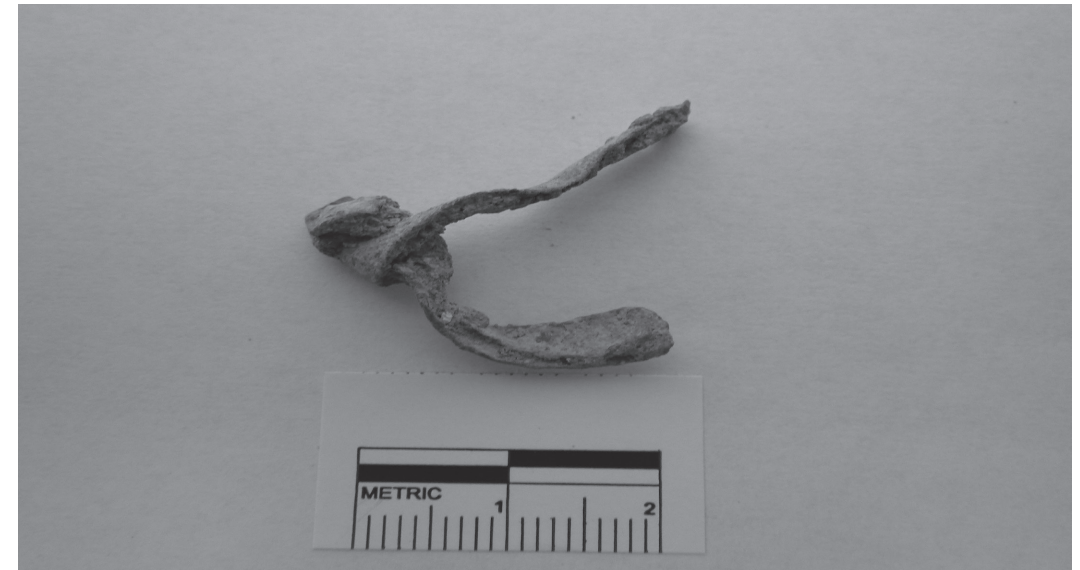
Figure 7. Vice-made, convex-sided window tie with a twisted end. (Photo by Timothy B. Riordan, 2018.)

The second type, represented by ten examples, looked like a small window lead that had been cut in half (FIG. 7). The exterior of the lead was convex, and the interior had a medial line that had been the channel of an H-shaped lead. This type had been previously reported from sites in New Jersey and Maryland. It had a range of width from 3.6 to 5.5 mm and a thickness ranging from 1.0 to 2.1 mm. Within this group there were three that had solder and one that was tied. There was also one curved section with a diameter of 14.9 mm.

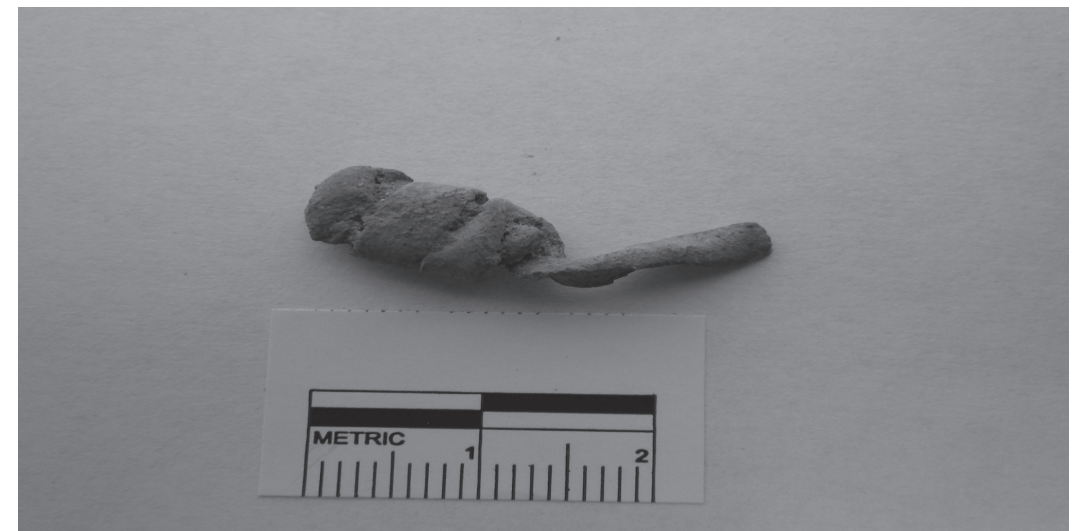
Figure 8. Vice-made, straight-sided window tie with a twisted end. (Photo by Timothy B. Riordan, 2018.)

The final variety also had ten examples. It consisted of cut window leads with a flat exterior and the interior medial line (FIG. 8). They ranged in width from 3.3 to 5.4 mm and in thickness from 1.2 to 2.3 mm. There were two pieces with solder and one tied piece. There were three curved pieces, one of which retained a portion of an iron saddle-bar with a diameter of 10.8 mm. The other two curved segments, which showed no iron staining, had diameters of 7.7 and 11 mm, respectively. All three curved segments had the medial line on the interior of the curve.
