Northeast Historical Archaeology

Volume 12 1983 *Symposium on Archaeology of the
Revolutionary War Period Held at New Windsor
Cantonment State Historic Site, New Windsor, New
York*

The Excavation of the Privateer Defence

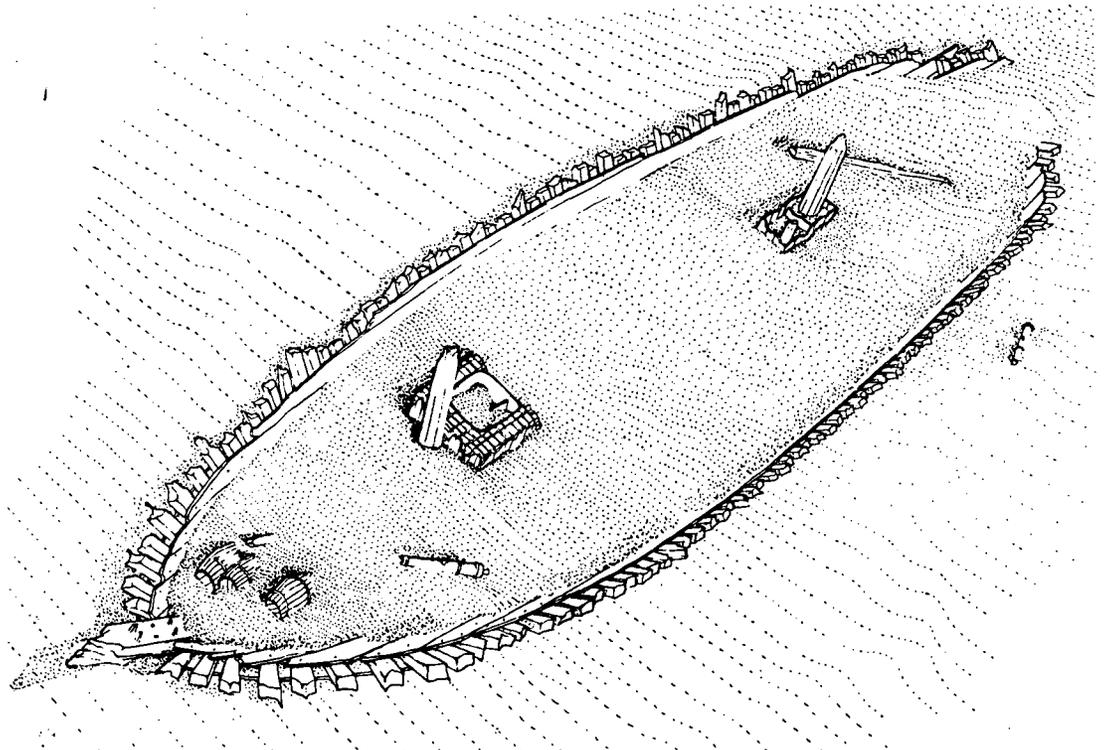
Figure 1. Imbedded hull with frame ends, mast stumps, stove, and shotlocker protruding above the seabed. (Drawing by Peter Hentschel.)

which was to recover the contents of an eighteenth century time capsule (Figure 1).

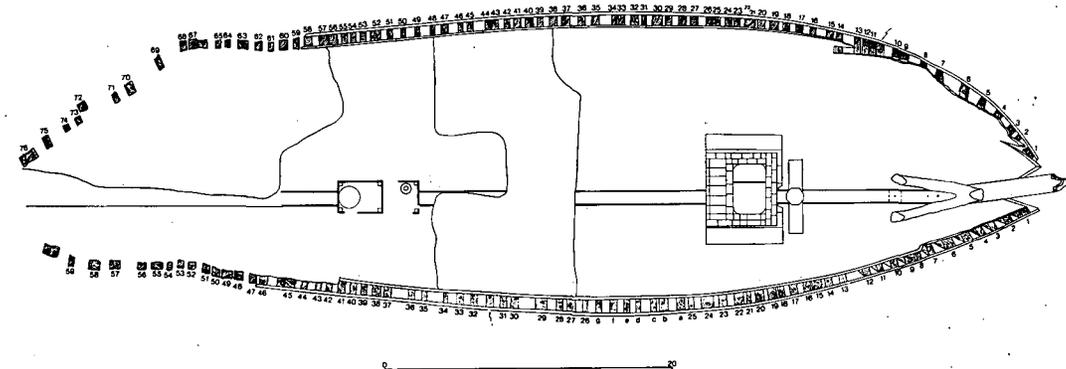
Figure 2. Site plan showing areas excavated as of 1978. (Drawing by David B. Wyman and Sheli O. Smith.)

Because it was impossible to view the wreck in its entirety due to minimal visibility, one goal of the survey was to complete an accurate map or plan of the wreck. It was impossible to do so by means of a plane table technique; instead the perimeter of the wreck was mapped by means of triangulation. Ends of frames that protruded above the seabed were numbered. Stations or base points were established at stem, mast stumps, and designated frames. From these points the

position of all exposed structure was triangulated using tape measures. Angular measurements combined with plan view dimensions of exposed structure provided the ingredients of an extremely accurate map of the outline of the imbedded hull (Figure 2).

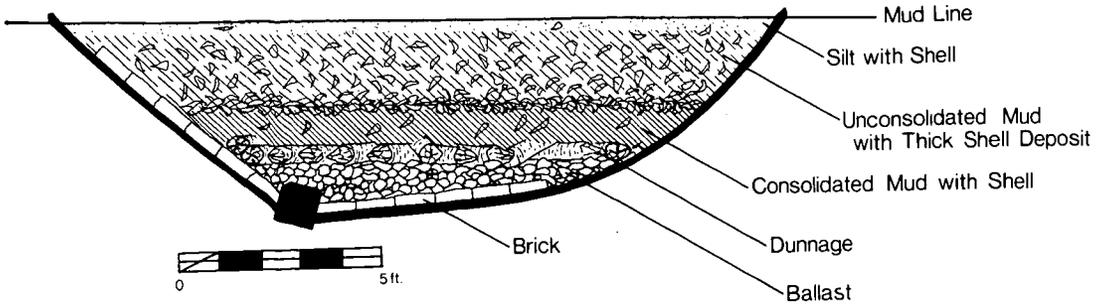
Figure 3. Transverse section of the hull at frame #25. The composition of the overburden was found to be consistent throughout the hull. Bricks, loosely laid, extended a few feet aft of the stove fire box, presumably as protection against sparks. (Drawing by Shell O. Smith.)

Depth measurements obtained by means of a probe rod revealed that the hull was imbedded with a list to port of 15 or 16

degrees. While the starboard side was rotted away just above the turn of the bilge, the port side was intact to a point a bit below where deck timbers had once crossed. Thanks to the silt and viscous mud that comprised the overburden that had been deposited on the hull, an anaerobic environment had been created which protected the buried hull structure and its organic contents from decay or destruction by marine organisms (Figure 3).

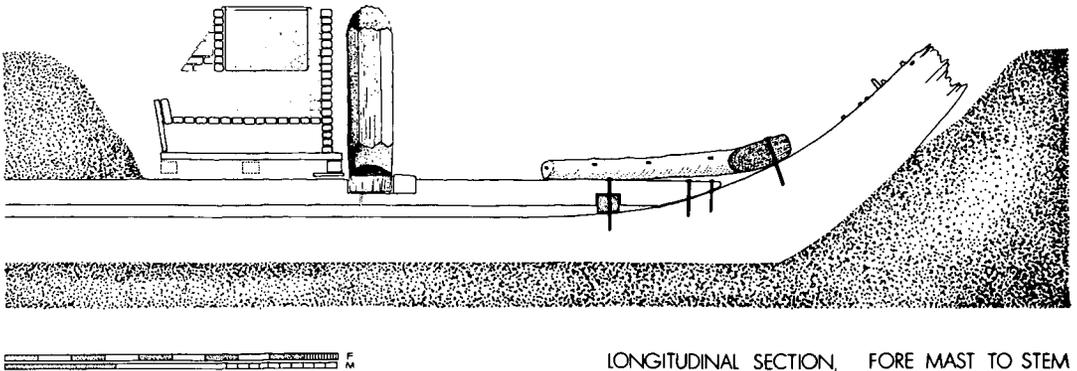
LONGITUDINAL SECTION, FORE MAST TO STEM

Figure 4. Bow in longitudinal section, foremast to stem. (Drawing by Peter Hentschel.)

The excavation of the bow provided a forecast as to the amount and variety of material culture contained within the hull. An athwartship trench located immediately forward of the galley stove yielded representatives or samples of nearly every category of artifact to be recovered as the excavation of the hull progressed. The distribution pattern of the finds in the trench also provided information relative to the process of deterioration of that portion of the hull that had been exposed and unprotected from the effects of salinity and marine organisms (Figure 4).

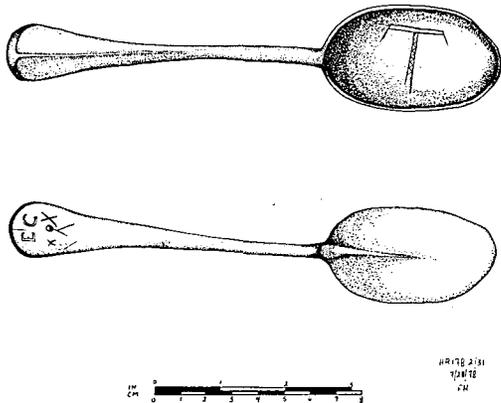
Figure 5. Pewter spoon bearing maker's mark EC and possibly the initial of its owner. Note the wear-induced indentation on the edge of the bowl. (Drawing by Faith Harrington.)

Most prolific in terms of variety are those artifacts associated with provision storage, food preparation, and messing activities. Included in the collection are 17 pewter spoons with three distinct spatula and bowl shapes spanning styles from the early through mid eighteenth century. Represented are varieties of craftsmanship including what may be home molded as well as shop made. One spoon bears a London mark and the name Swanson; another with an embossed EC may be the product of a Boston pewterer, Ephraim Cobb (Figure 5). Many of the spoons have crudely scratched initials or enigmatic symbols. Among the eating utensils were also two wooden whittled spoons, one a fairly faithful copy of a pewter counterpart. Iron, unless cast, did not fare well during the period when the hull of Defence was subjected to a pre-embedding non-anaerobic environment. However, a bone handle of at least one knife was recovered from the galley area.

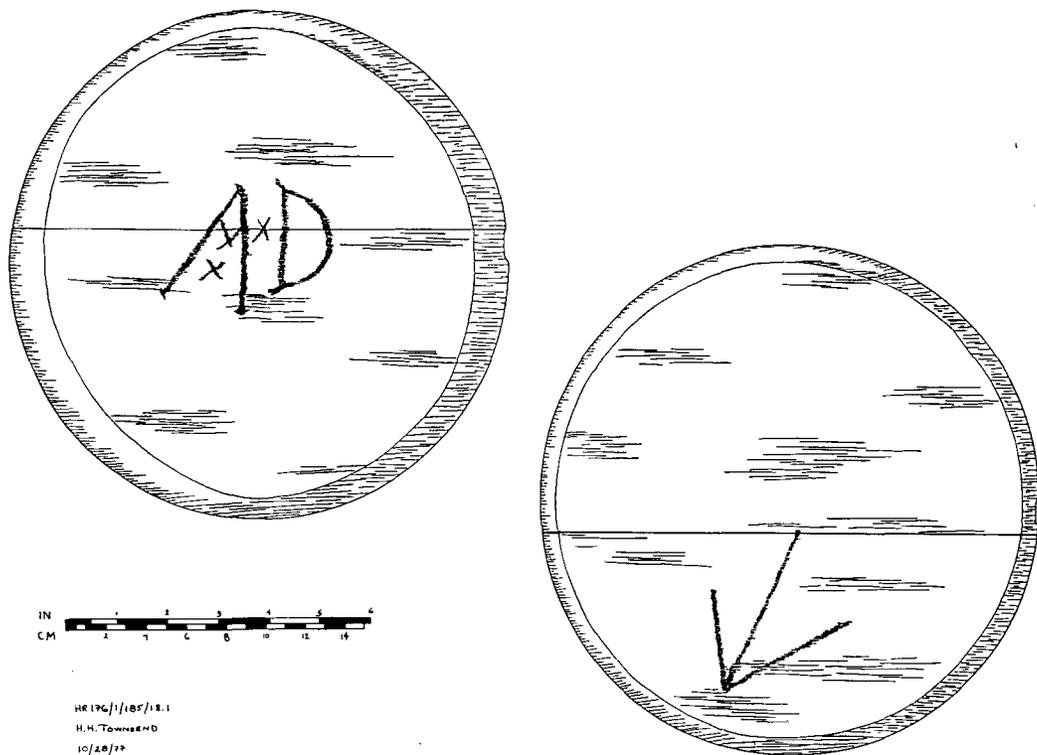
Figure 6. Base of a mess kid, a small stave-built container used to distribute allotted portions of food to a mess section. (Drawing by Helen H. Townsend.)

Evidence of some of the staples carried onboard Defence were found in the barrels stowed in the bow which contained the remnants reduced to ax-butchered beef and pork bones. The barrels, some intact, are 32-gallon capacity, many of the sharp croze wet variety. Along with barrel cooperage, stave-built containers include varieties of so-called white cooperage such as tankards and mess buckets or kids in which seamen received their portions of "salt horse" and "pease". Like the spoons, the kids and tankards bear graffiti such as carved initials and other markings, including a broad arrow (Figure 6).

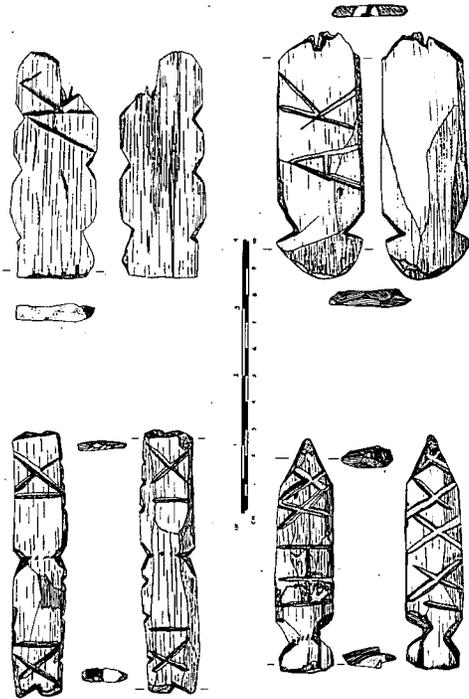
Figure 7. Four of a number of wooden tags found in the galley area. Their function, it is believed, was to identify portions of boiled down beef allocated to a particular mess section. (Drawing by Helen H. Townsend.)

Small wooden tags found in the galley area also carry initials and markings. Thought at first to be gaming pieces, the tags—some carved to resemble projectile points—are now known to have been used to designate a particular mess section of six or seven seamen. With string a tag was tied to a chunk of meat to be boiled down in the galley stove cauldron with the tag hanging over the side. At mess call, the "captain" of a mess section went to the galley with a kid and by means of the tag identified his portion which was carried back to be shared with his mess mates (Figure 7).

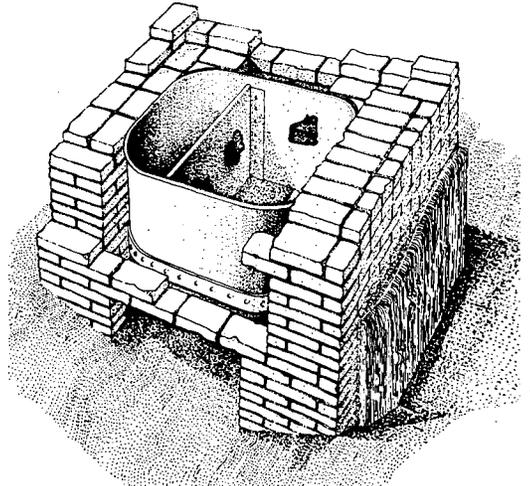
Figure 8. Galley stove with copper cauldron. (Drawing by Peter Hentschel.)

As unique as the tags is the cauldron of 68-gallon capacity. Constructed of rivetted sections of hammered native copper, it is an object often described or referred to in maritime literature; however, few have found their way to museum collections (Figure 8).

Rare, too, are examples of galley cookstoves. Although often depicted in reference books, examples of original structures are restricted to preserved or restored vessels such as Wasa, Victory, and Constitution. The brick stove of Defence standing five feet high and nearly as wide is,

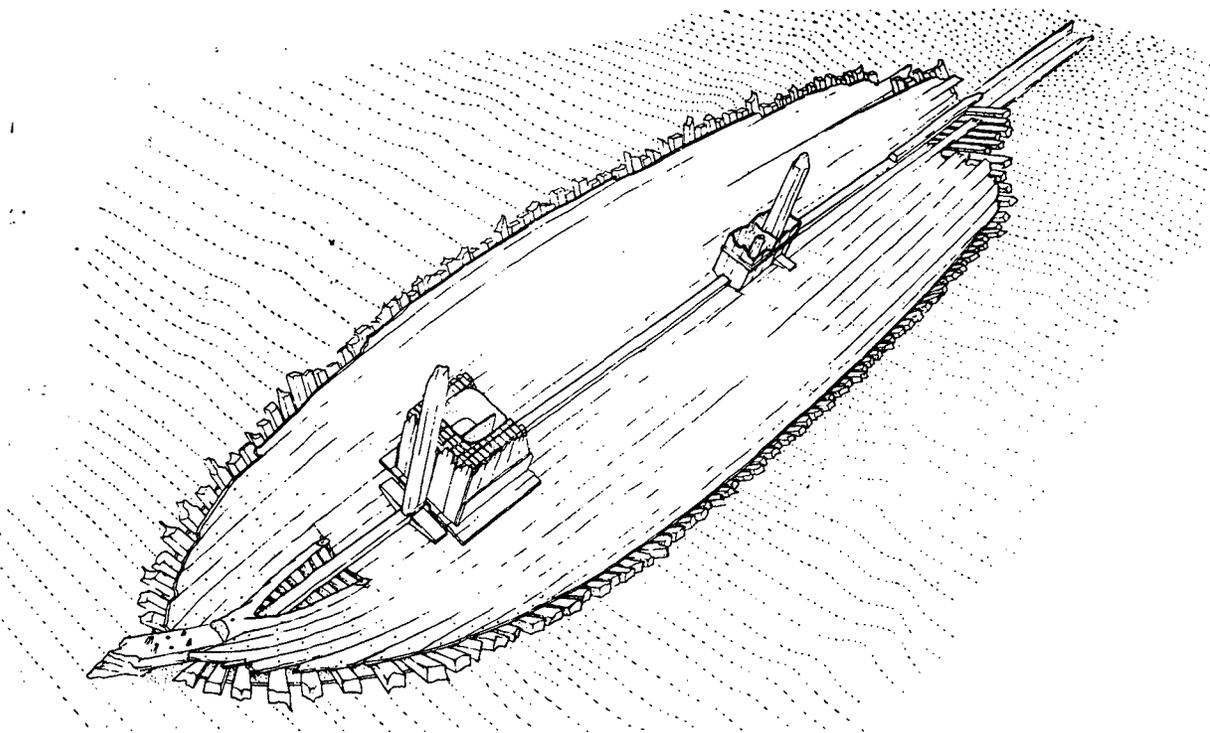
Figure 9. Excavated hull with the stern damaged as a result of the charge set off to scuttle the vessel. The structure surrounding the main mast is the bilge pump well and shotlocker. (Drawing by Peter Hentschel.)

Documentation of the hull structure began in 1976, and each successive field season saw the accumulation of dimensional data and the recording of structural details. Through the length of the hull twelve transverse sections or profiles were measured. Removal of ceiling planking revealed hidden details of construction. This information has been incorporated into a naval architectural plan of Defence which depicts a number of interesting features (Figure 9).

For instance, Defence was not the usual full-bodied product of a New England shipyard. Rather, her hull in profile is more angular with considerable dead rise. Her bow instead of being bluff or "apple cheeked" is quite sharp, attested to by the absence of hawse pieces and the inclusion of canted frames. In general, the characteristics of the hull of Defence strongly suggest the influence of design migration. She very much resembles vessels constructed in the eighteenth century in the Chesapeake area. Referred to sometimes as "Virginia built," these sharply built vessels are examples of a design tradition that was distinctly American.
