Hsu, Dick Ping (1972) "Fort Stanwix," *Northeast Historical Archaeology*: Vol. 2 2, Article 5.
<https://doi.org/10.22191/neha/vol2/iss1/5> Available at: <http://orb.binghamton.edu/neha/vol2/iss1/5>

ARCHAEOLOGICAL EXCAVATIONS AND ARCHITECTURE AT FORT STANWIX, ROME, NEW YORK

Dick Ping Hsu

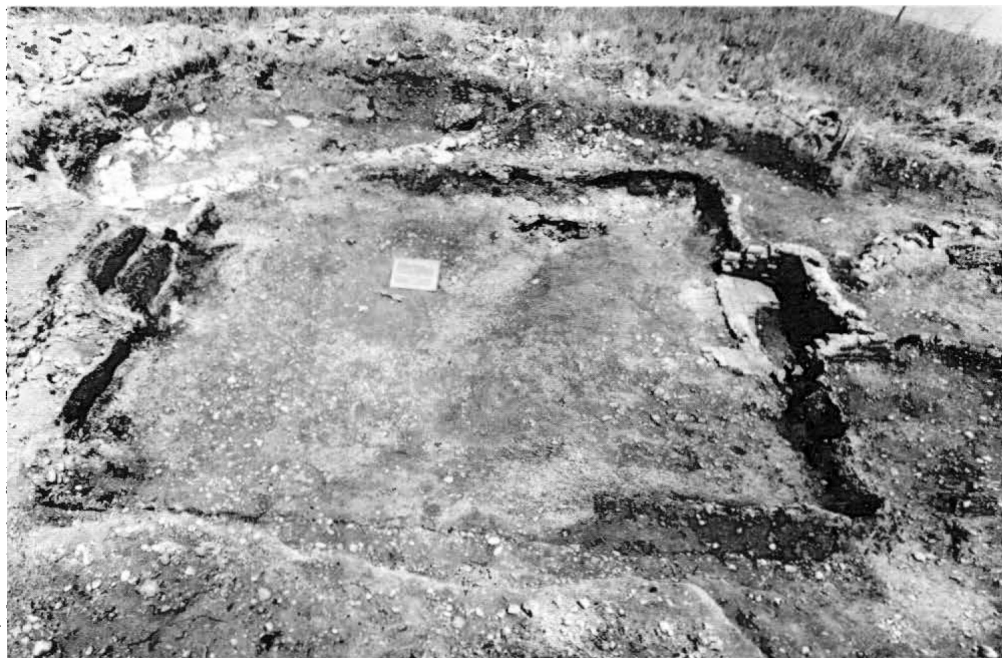
Fig. 10— Bakehouse and oven located in the southeast bastion, originally built as a bombproof in 1776-77 period. Hearth and oven were built over the collapsed 1758 powder magazine. —*National Park Service photo.*

The southeast bombproof was excavated in 1965 and has been referred to as the bakehouse.⁴ It was not until after the southwest bombproof was excavated that the original purpose and period of this structure became clear. There was one layer of burned wood reported by Duncan Campbell in the original excavation. He thought it was the remains of the wall. The brick oven and hearth added to this structure were located in the center of the wall opposite the door. Only the base course of the oven remained. It was elliptical in shape, measuring approximately 9 feet wide and 13 feet long and lay partially over the collapsed 1758 powder magazine.

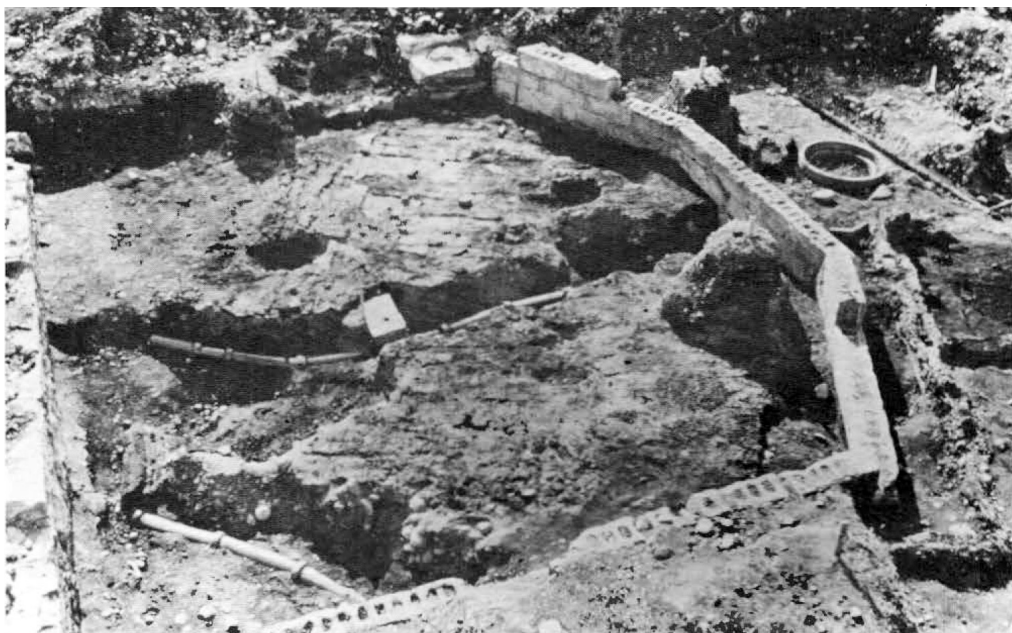
Fig. 11— Floor planks and wall of southwest bombproof. Foundation and drain pipes of 19th and 20th century construction destroyed a great deal of this structure. —*National Park Service photo.*

The floor of the southwest bombproof was made of planks; the outer planks ran parallel with the nearest wall, the center plank ran from front to rear of the structure. The roof was also made from planks. Near the wall opposite the entrance was an area where lead balls were being manufactured, lead sprues and balls were on and below the floor planks.
